MAINTENANCE

APPLICATIONS OF MICROSURFACING PROCESSES TO PAVEMENT REPAIR WORK

Technical Laboratory, The NIPPON ROAD CO.,LTD

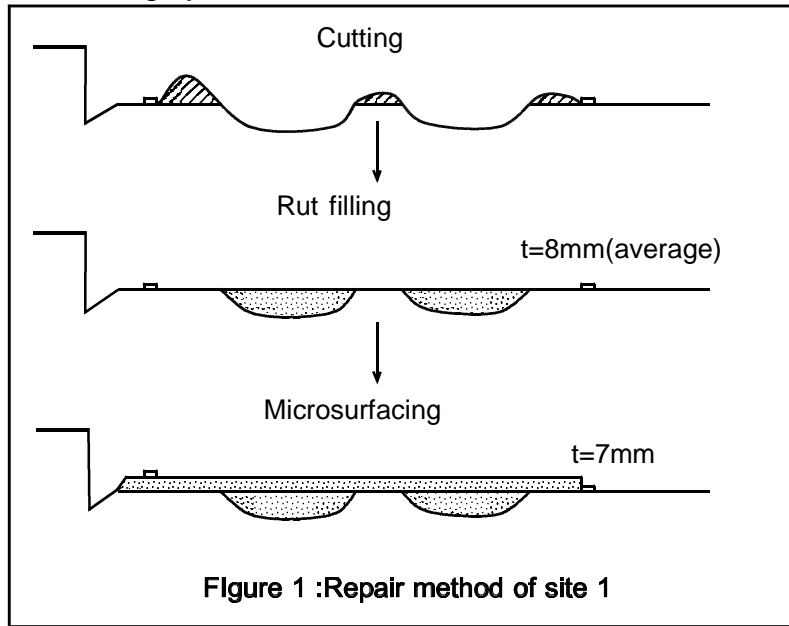
Rutting was found on the whole surface due to mixture flow. Repairs had been carried out once in the past by means of road surface cutting, but the rutting was still found thereafter. The plastic deformation of the mixture was severe, and both edges of the wheel path were protruding 10 - 15 mm more than the design road surface elevation.

For the case of using microsurfacing in the repair of the road surface with rutting, it was not suitable to repair the rutting using only microsurfacing because of poor spreadability, cost effectiveness, and delay in the development of the mixture strength. Therefore, the work was performed applying microsurfacing after cutting vaults in both sides of ruts.

After cutting the vaults, ruts were filled using microsurfacing mixture. The road was served to traffic for 2 - 3 days because mixture's consolidation by traffic was expected, then a layer of microsurfacing was spread over the whole area. The rut filling thickness was an average of 8 mm, and the microsurfacing layer was 7 mm (Figure 1).

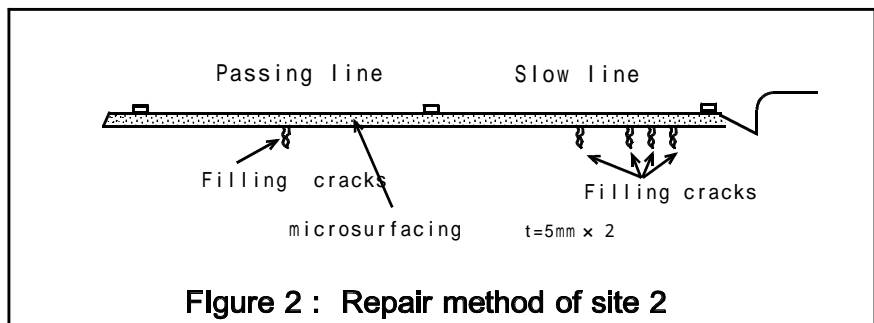
Cracking was found over the whole area, and it was particularly concentrated in the

vicinity of the outer wheel path.

Along with a certain amount of structural defect, it was thought that the cracking was initiated due to deterioration of the mixture because the subgrade CBR using FWD showed no significant difference between cracked and non-cracked sites. The width of the cracking was about 2 - 3 mm.

Pavement with cracking at site2 was repaired by pouring filling agent into the cracks that had occurred on the existing pavement surface, and then two layers of microsurfacing were

applied over the whole area. Each layer was 5 mm thick, giving a total thickness of 10 mm (Figure 2).

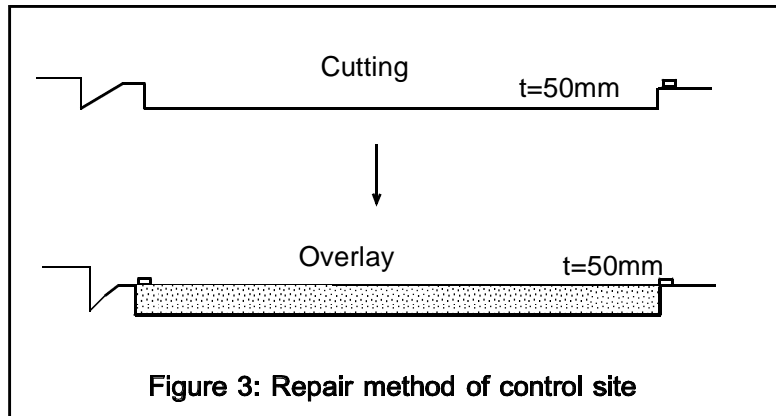
The existing pavement conditions were roughly the same as those of site 1.

After cutting the existing pavement surface an average depth of 50 mm, it was resurfaced with 50 mm thick hot mix asphalt concrete (Figure 3).

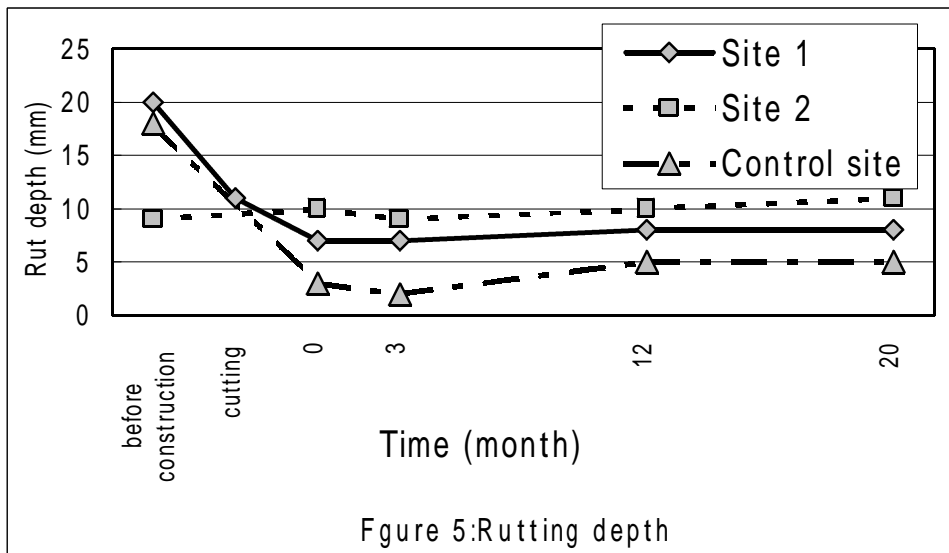
The rutting depth of the existing pavement in site 1 was an average of 20 mm, and after cutting the surface's vaults the rutting depth was 11 mm. Then, after the rut filling and microsurfacing layer work, the rutting depth became 7 mm. Therefore, the rutting was improved by 9 mm as a result of the road surface cutting, and by 4 mm as a result of microsurfacing.

Also, after construction, the increase in the rutting depth of the sites which used

microsurfacing after they were served to public traffic was 1 - 2 mm, while that of the control site was 3 mm. Therefore, the plastic flow resistance of 5 cm of resurfacing and of microsurfacing are, in the current situation, about the same.

In the case of deep rutting repair, because there is a limit to the layer thickness when using microsurfacing and the consolidation amount is large, deep rutting can not be repaired completely. However, it is clear that rutting repair is possible by microsurfacing after surface cutting work. The progression of rutting after service to traffic, even though it is after only one summer, indicates that it is equivalent to the milling and resurfacing method. In the experiment, it was found that the road surface flow resistance improved by applying 10 mm of microsurfacing on conventional hot mix asphalt.

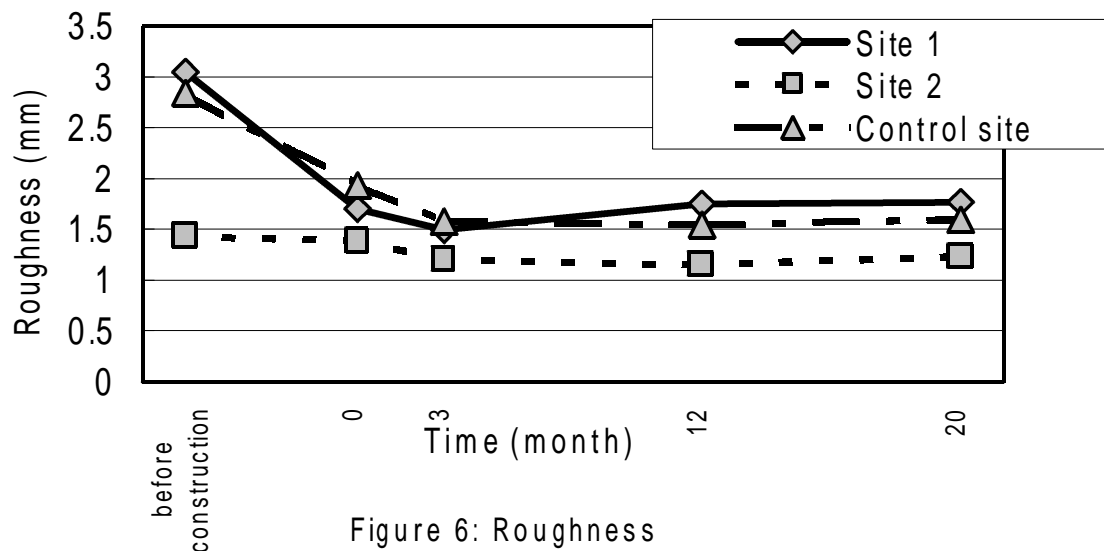
Figure 6: Roughness

Figure 6 shows that the roughness of site 1 was improved after repairs by cutting. Also, the improvement on the control site with surface milling and resurfacing work was almost same as for site 1. The roughness improvement could not be recognized, because only 10 mm of microsurfacing was applied on site 2, and the shape of the existing pavement surface was not changed.

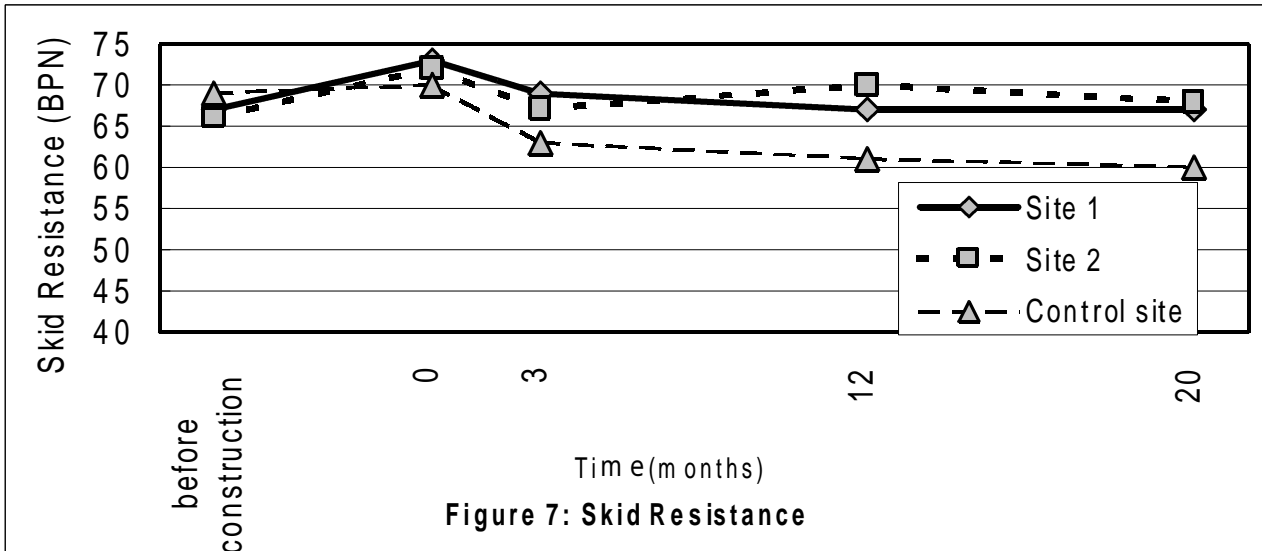
The skid resistance value of surface immediately after the microsurfacing layer applied was 72 BPN. The skid resistance value after 20 months was 68 BPN, indicating a

tendency to decrease gradually. The dense-graded asphalt mixture of the control site shows a similar tendency, however the tendency to decrease is larger than the skid resistance value decreasing to 61 BPN.

The microsurfacing layer still showed a large value in the skid resistance even though the degree of road surface texture had decreased after 20 months. This trend has not changed, even at the current time when the microsurfacing layer's road surface texture is finer than that of the dense-graded asphalt mixture. This can be attributed to the effective functioning of the microsurfacing layer's microtexture.

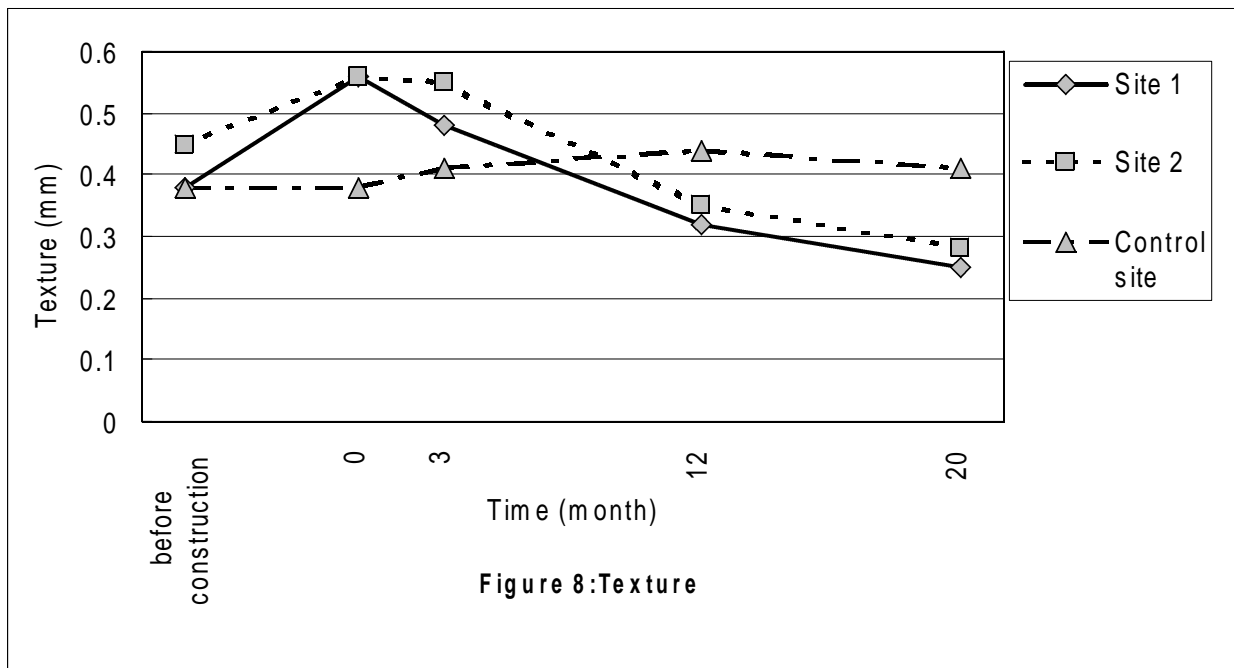
The degree of road surface texture was a high value immediately after the microsurfacing, however, this value dropped dramatically with time. The surface texture using the dense-graded asphalt mixture had the reverse trend after ten months, the surface texture levels were reversed, with the value for the dense-graded asphalt mixture showed larger value. It is thought that consolidation accompanying service makes the texture of microsurfacing layer macroscopically smooth, on the other hand, the fine part of the dense-graded asphalt mixture was scattered by the passing traffic resulting in a coarse surface.

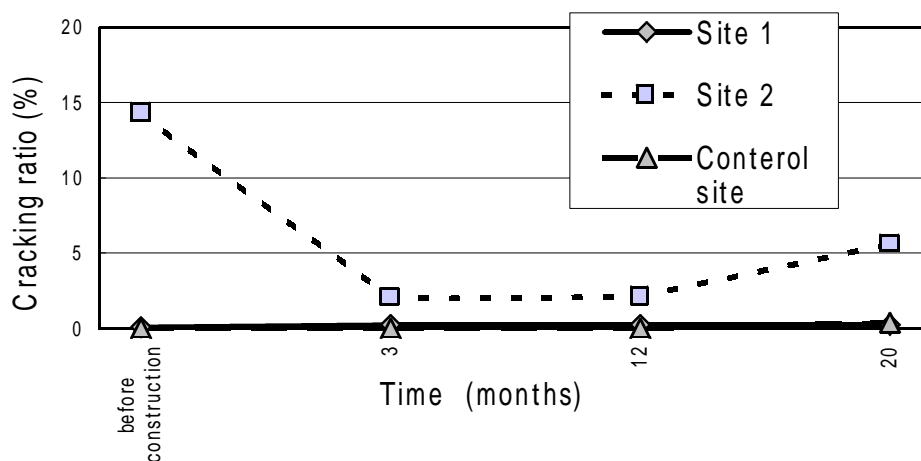
Figure 9:Crack

Cracking reflected underlying cracks of existing pavement was found at the early stage in site 1 and site 2. For site 2, the cracking ratio after 20 months was 5.7%. The number of reflective cracks during the approximately 2 years was 1/3 of the existing pavement cracks, then it was found the microsurfacing had less crack initiation effect. While it is necessary to observe the future cracking progress continuously, a pavement life prolongation effect and a life cycle cost reduction effect can be expected.
